## Robinson Helicopter Company Accident Report

AIRCRAFT MODEL:	<u>R44 Clipper I</u>
SERIAL NUMBER:	<u>1295</u>
REGISTRATION:	<u>N7530R</u>
ACCIDENT DATE:	<u>30 January 2018</u>
ACCIDENT LOCATION:	<u>Newport Beach, California</u>
NTSB IDENTIFICATION:	<u>WPR18FA077</u>

REPORT WRITTEN BY: Ken Martin

DATE: 17 June 2019

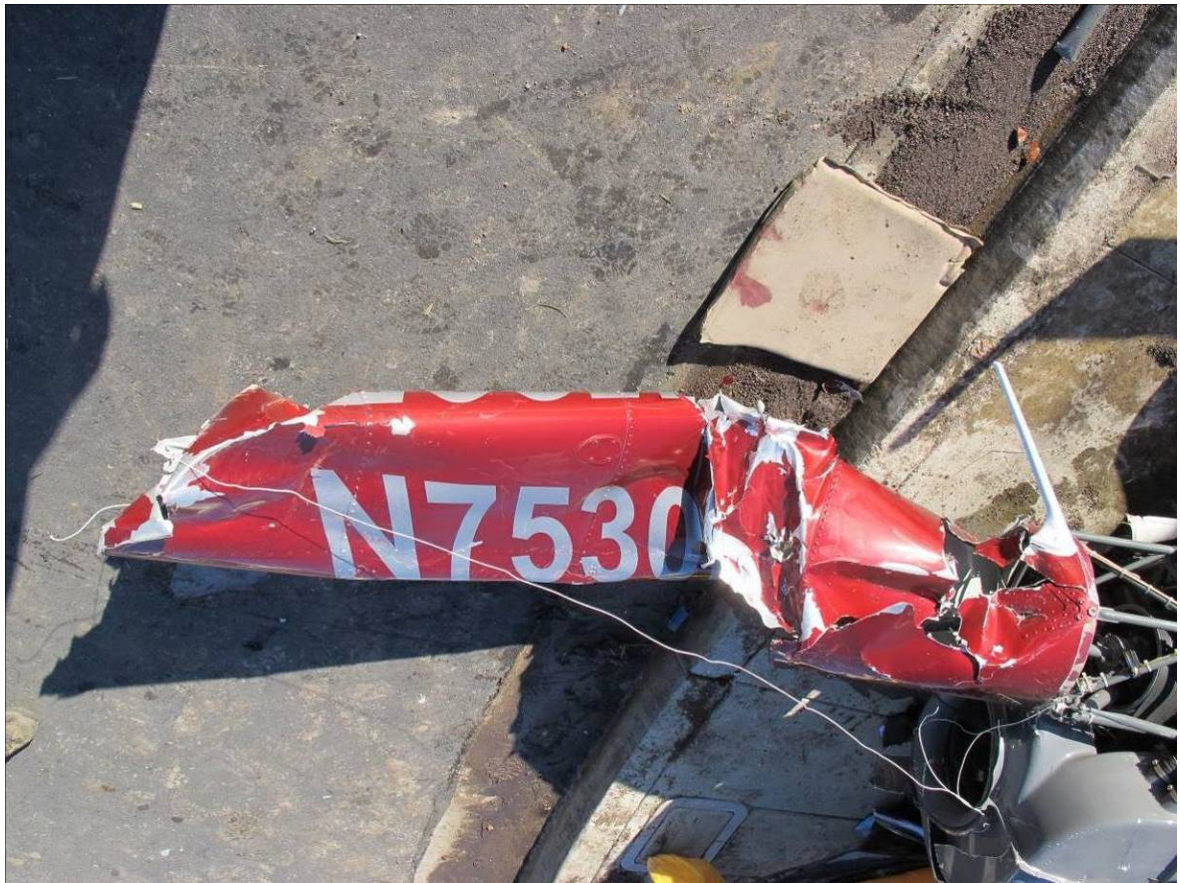
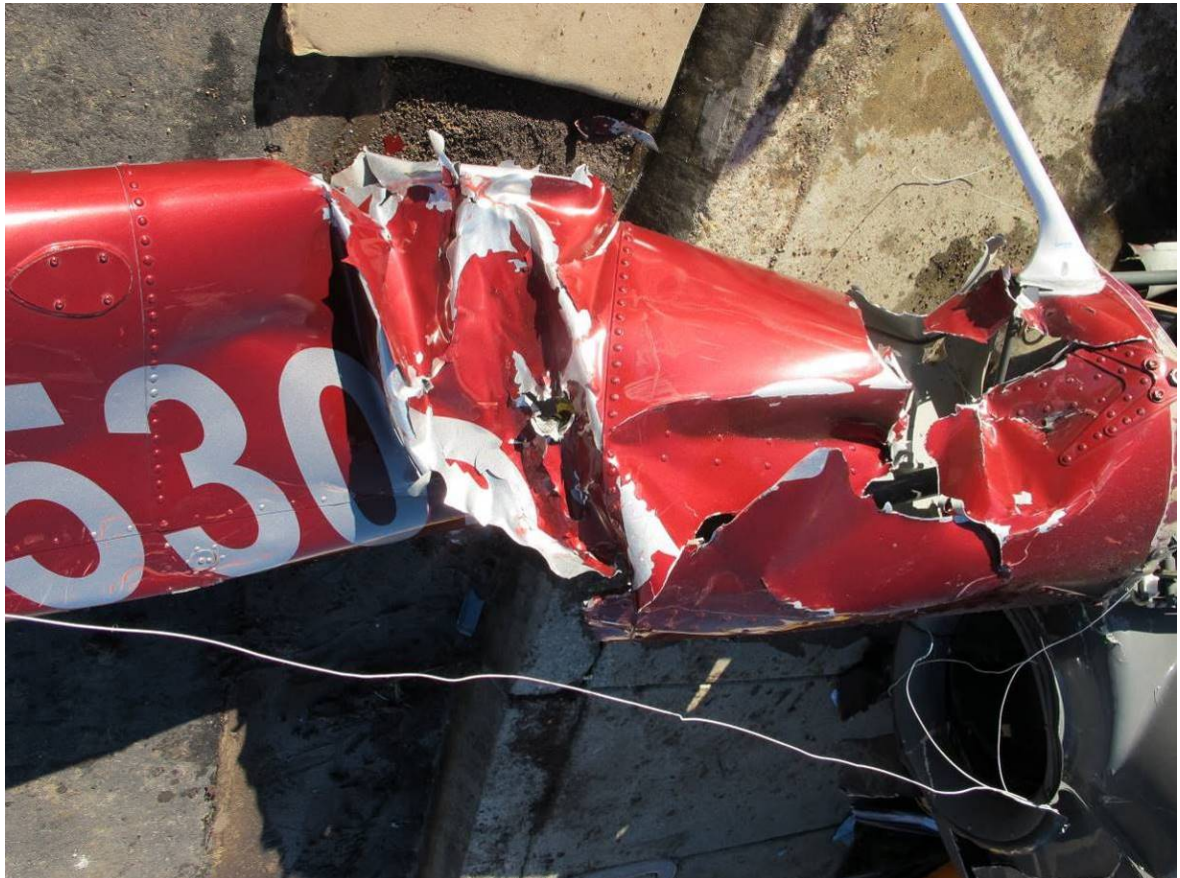
The tailcone was separated at the fourth bay and at the aft bulkhead. The surface of the fractures at the separations were angular and jagged. Tailcone bays one and two were crushed and fractured. Tailcone bays three and four were partially flattened. The aft section of tailcone was dented and scraped and had red porous material on the lower surface at each end which appeared to match the color and material of the roof tiles of the surrounding houses. Only small sections of the aft bulkhead remained attached to the tailcone. The empennage was detached and located per the wreckage distribution diagram. A small section of the aft bulkhead remained attached to the empennage.

The forward section of the tailcone, from the right

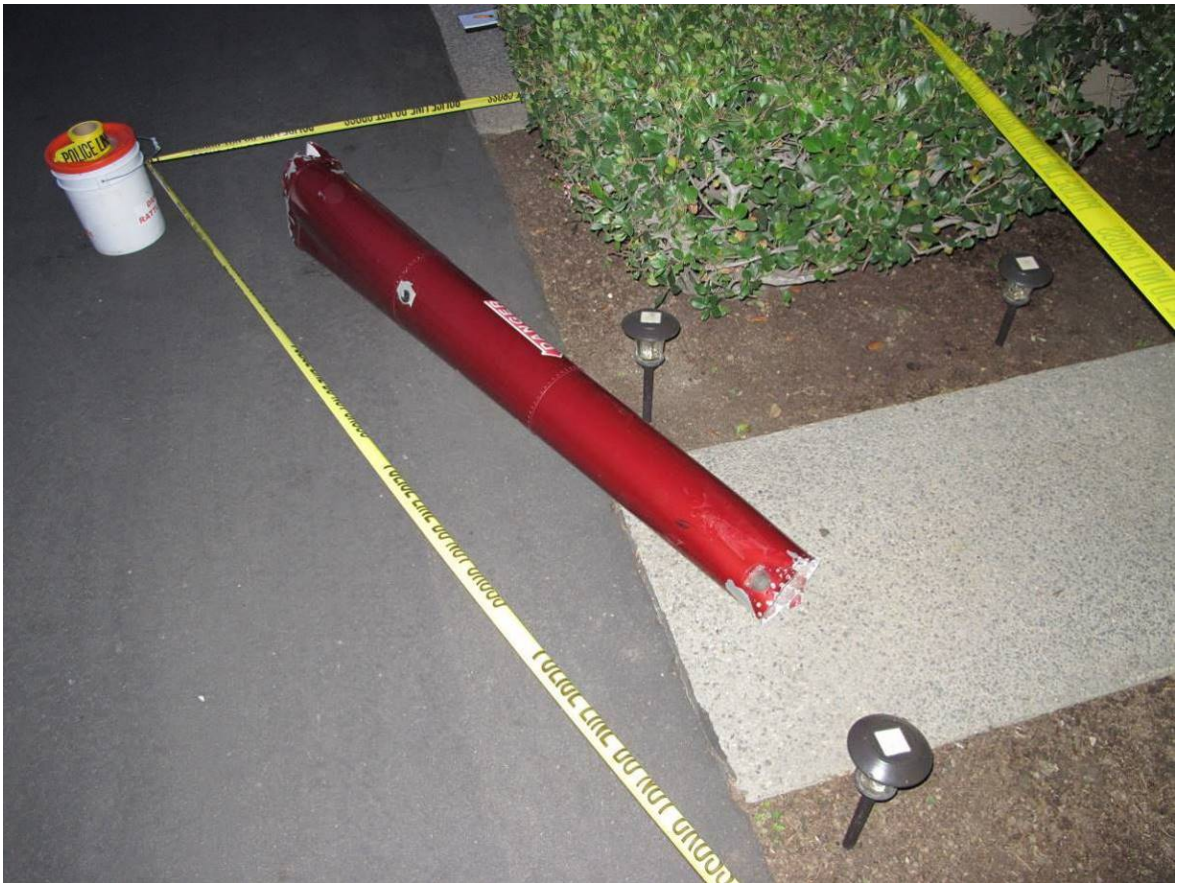
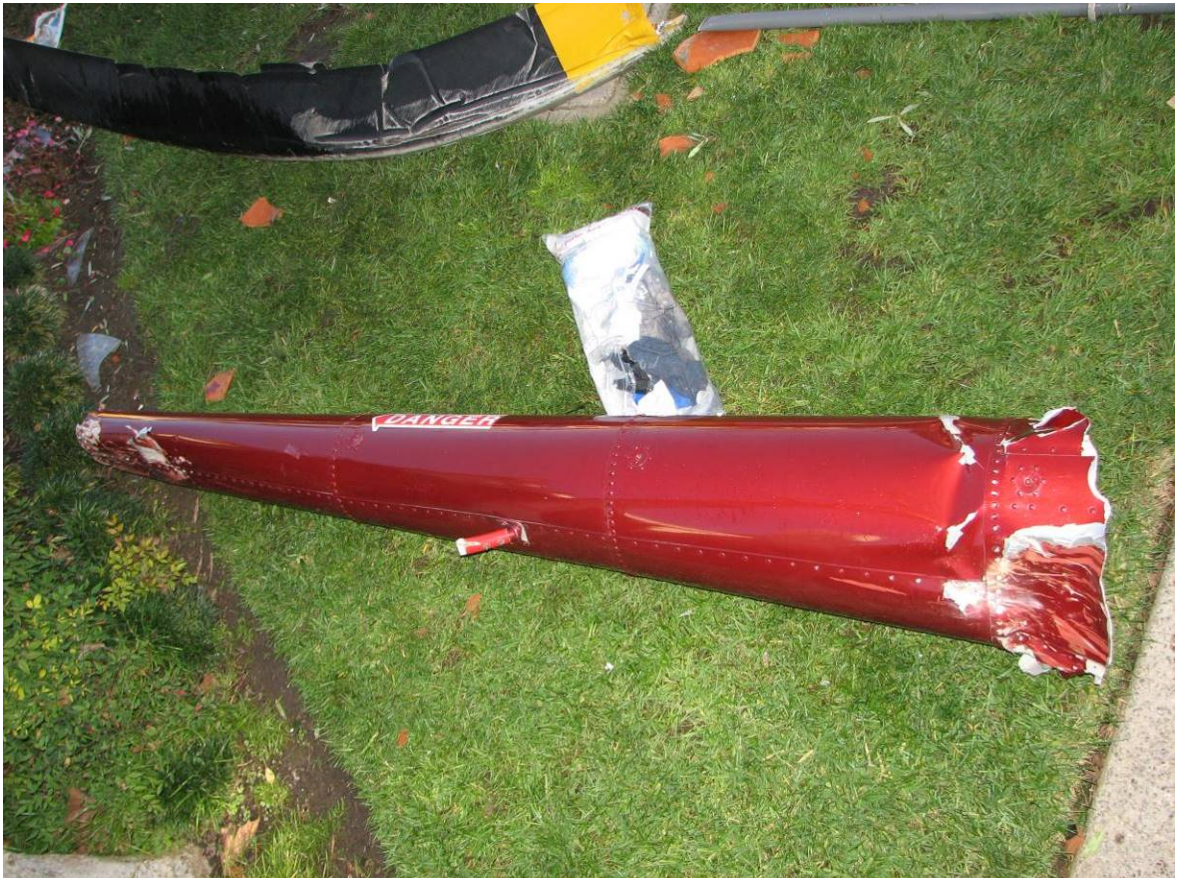
The aft section of the tailcone, as found at accident site

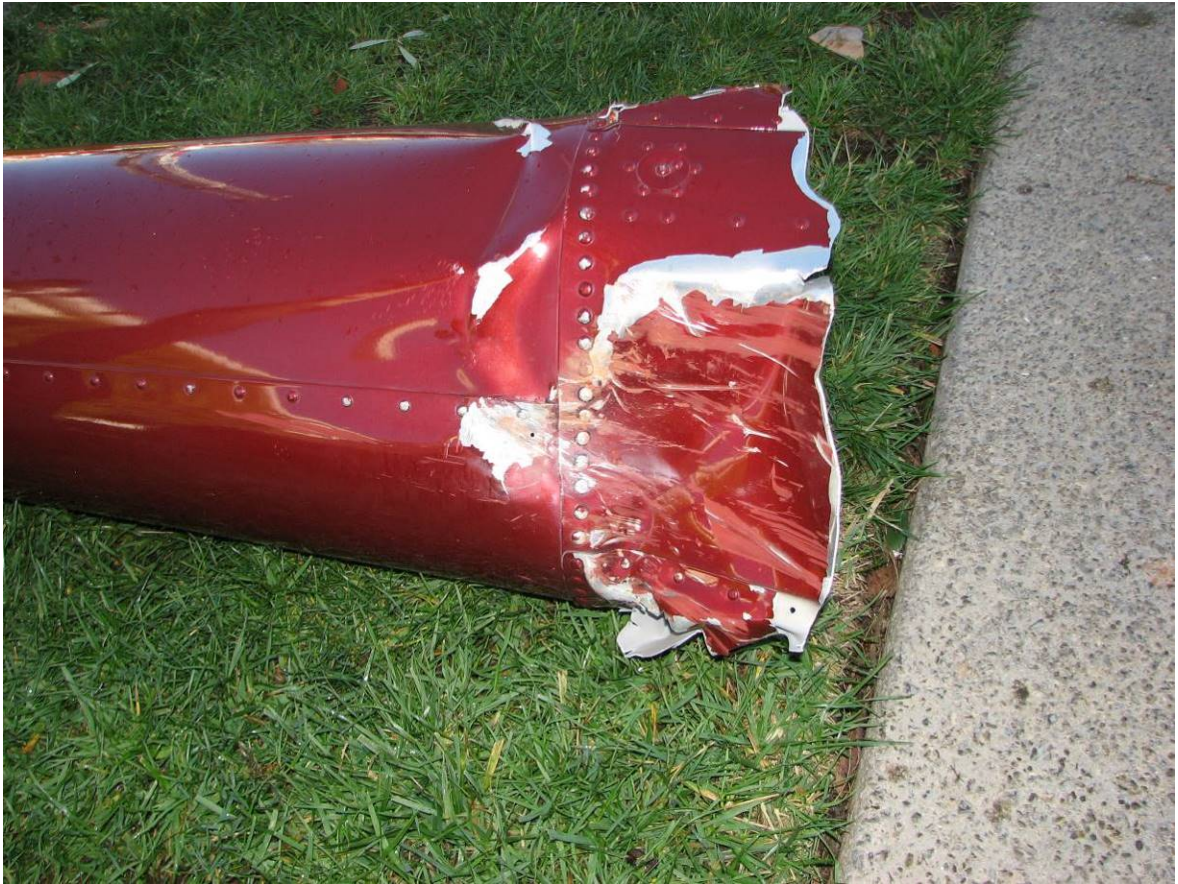
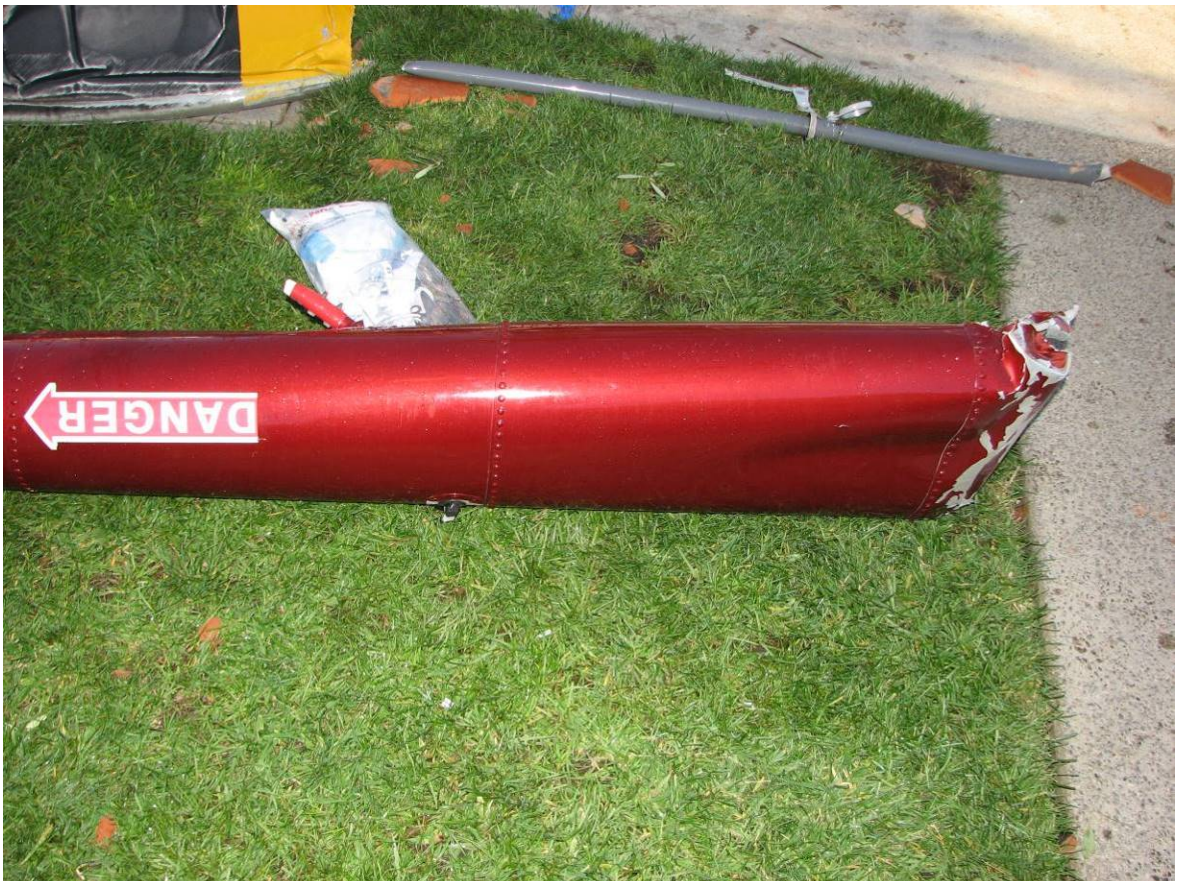
The aft section of the tailcone at the separation in bay 4

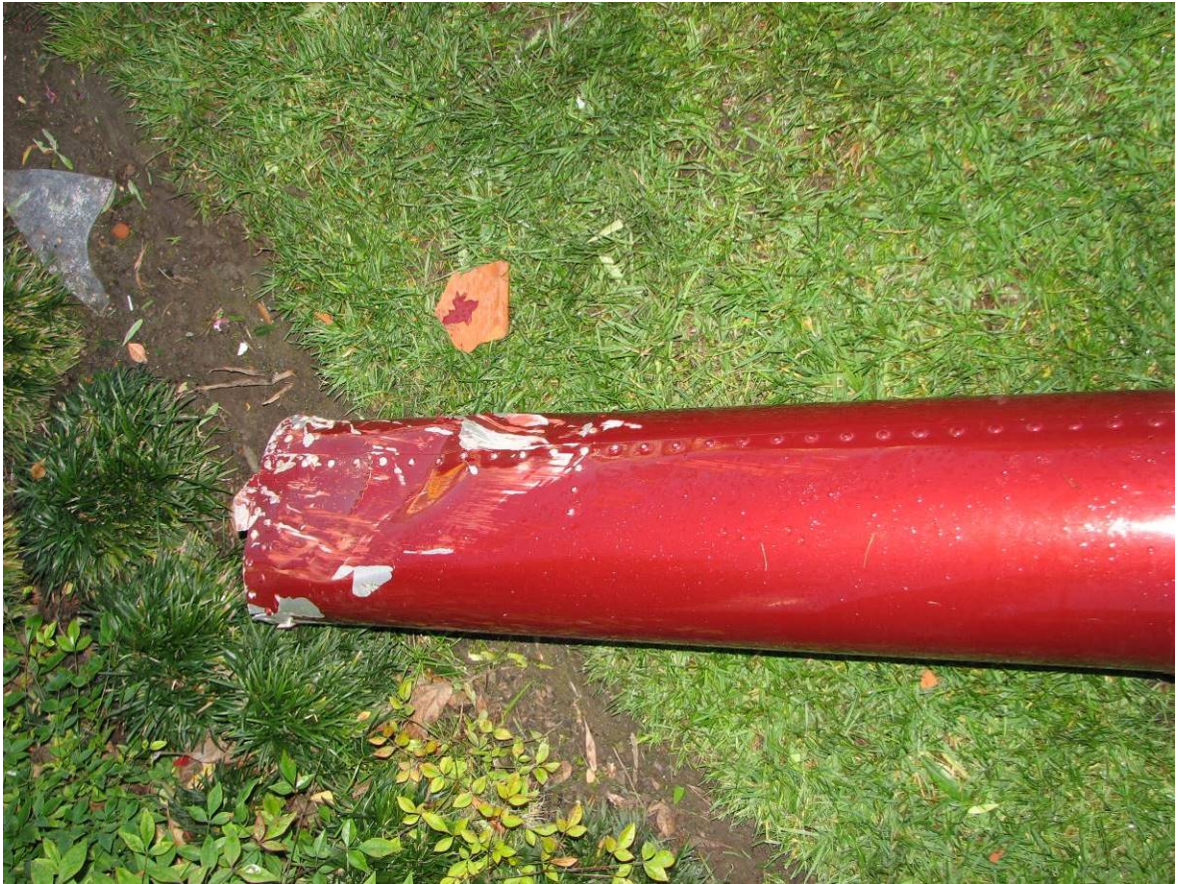
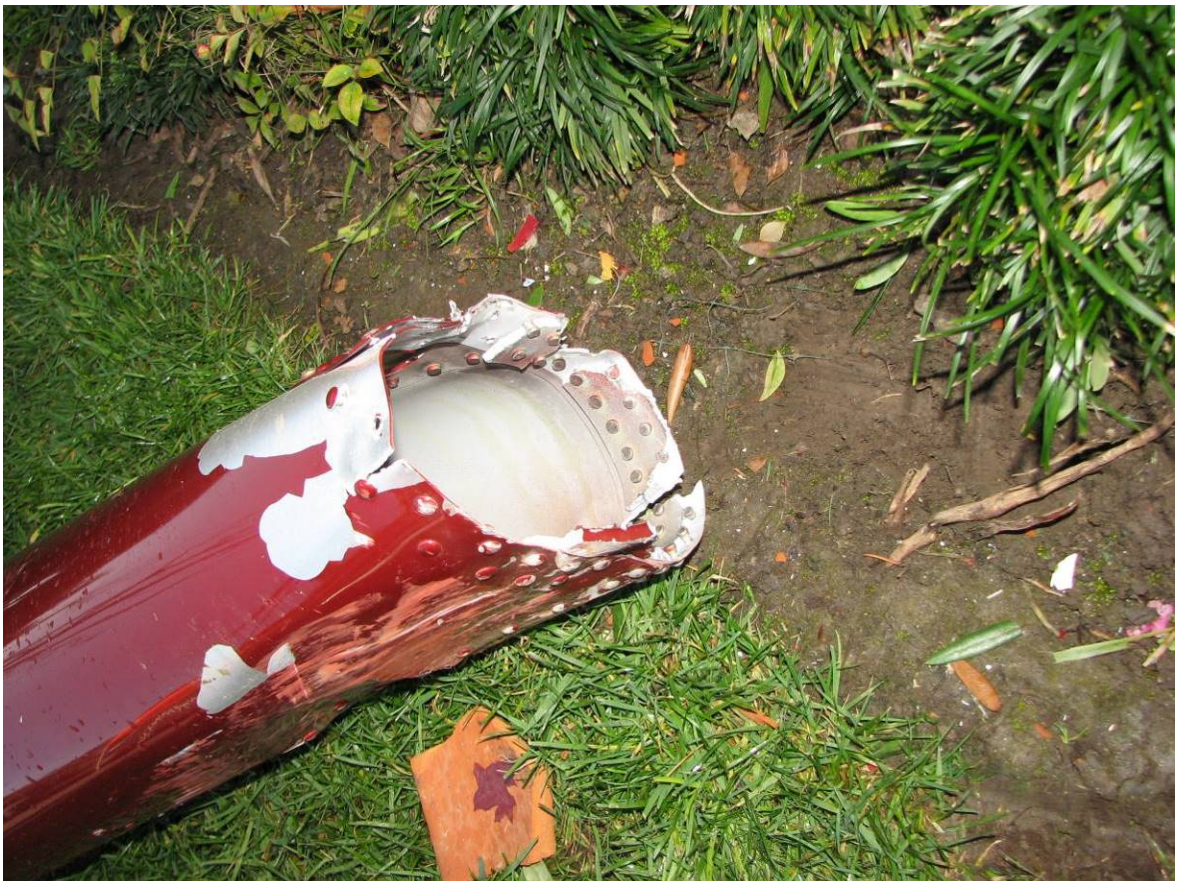
The aft section of the tailcone at the separation at the rear casting bulkhead

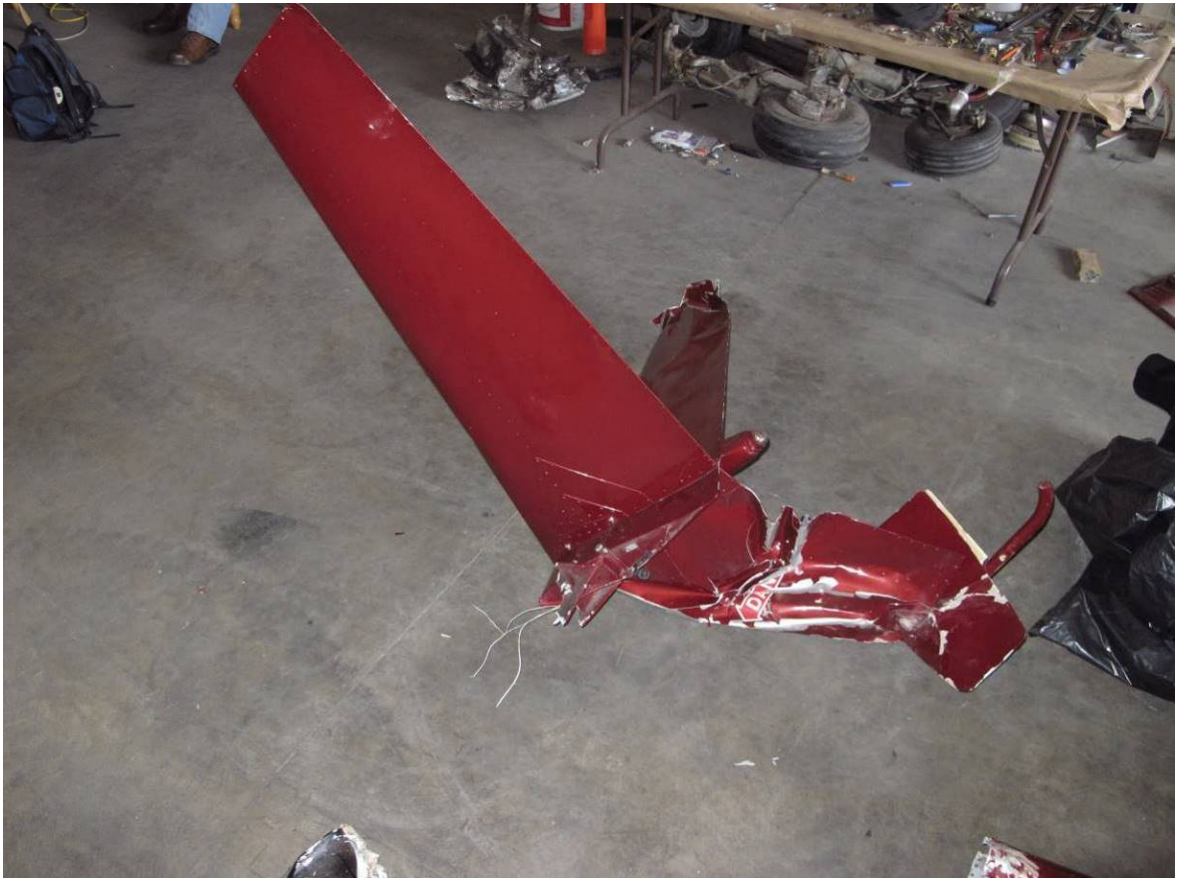
The upper vertical stabilizer had a small dent in the leading edge. The horizontal stabilizer was crushed inward at the tip. The lower vertical stabilizer was deformed upward and slightly to the right. The lower auxiliary stabilizer was fragmented and the tail skid was bent upward. Both the auxiliary stabilizer and the tail skid had scrape marks along with red porous material near their leading edges which appeared to match the color and material of the roof tiles of the surrounding houses.

The upper vertical stabilizer

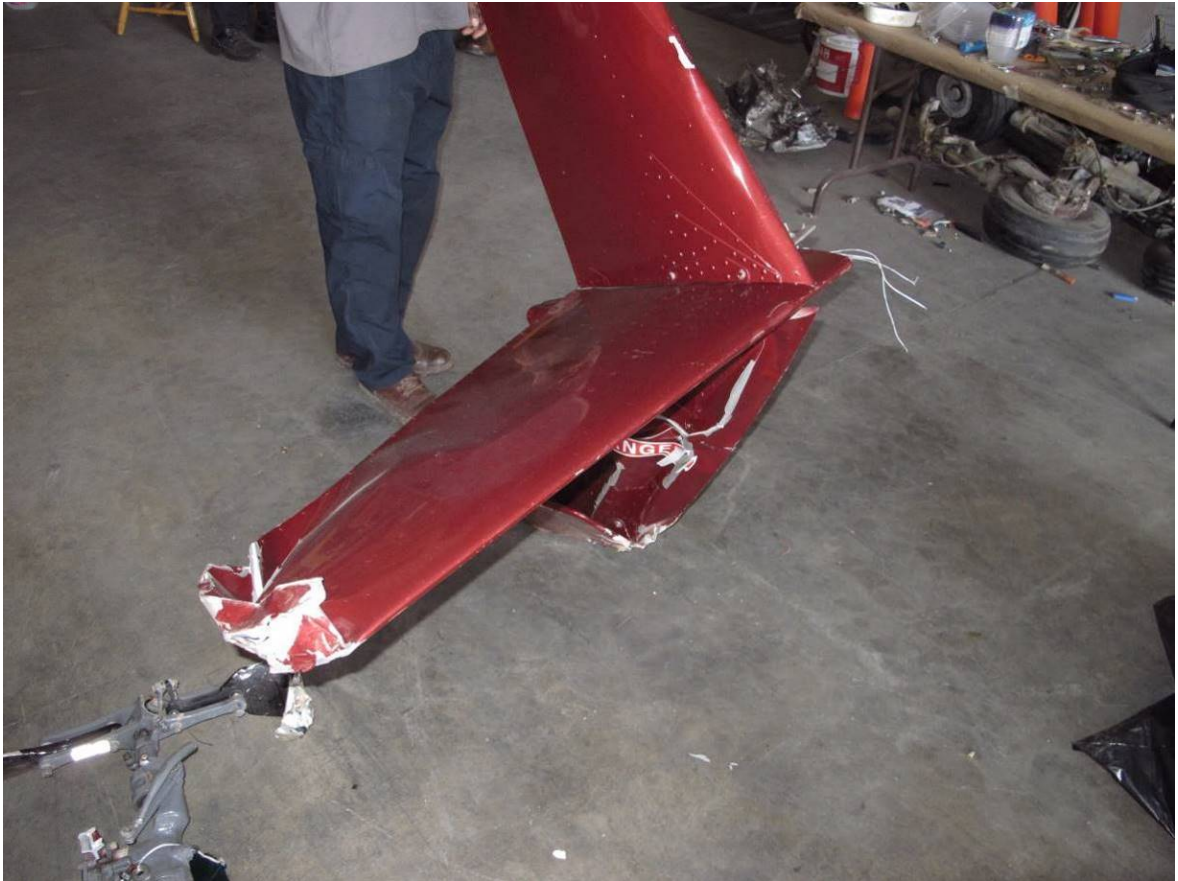
The horizontal stabilizer

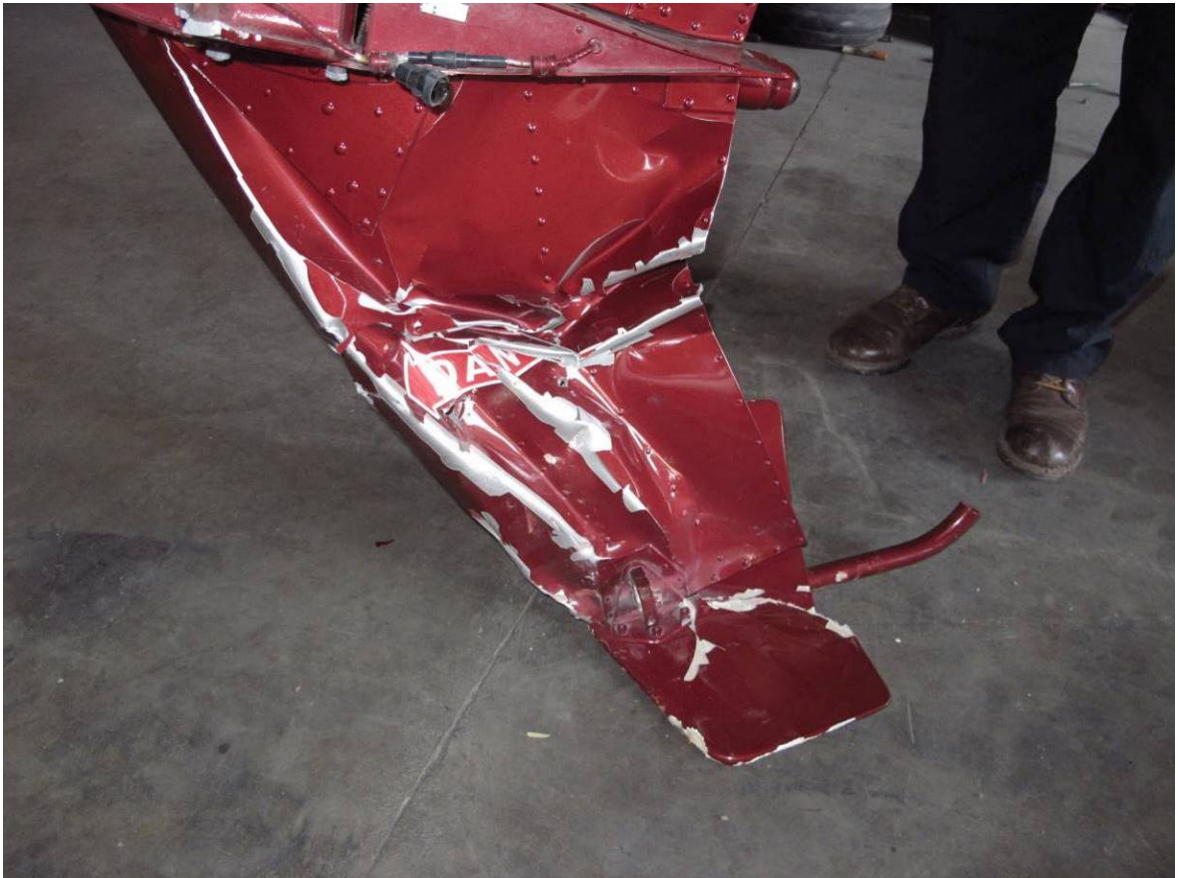
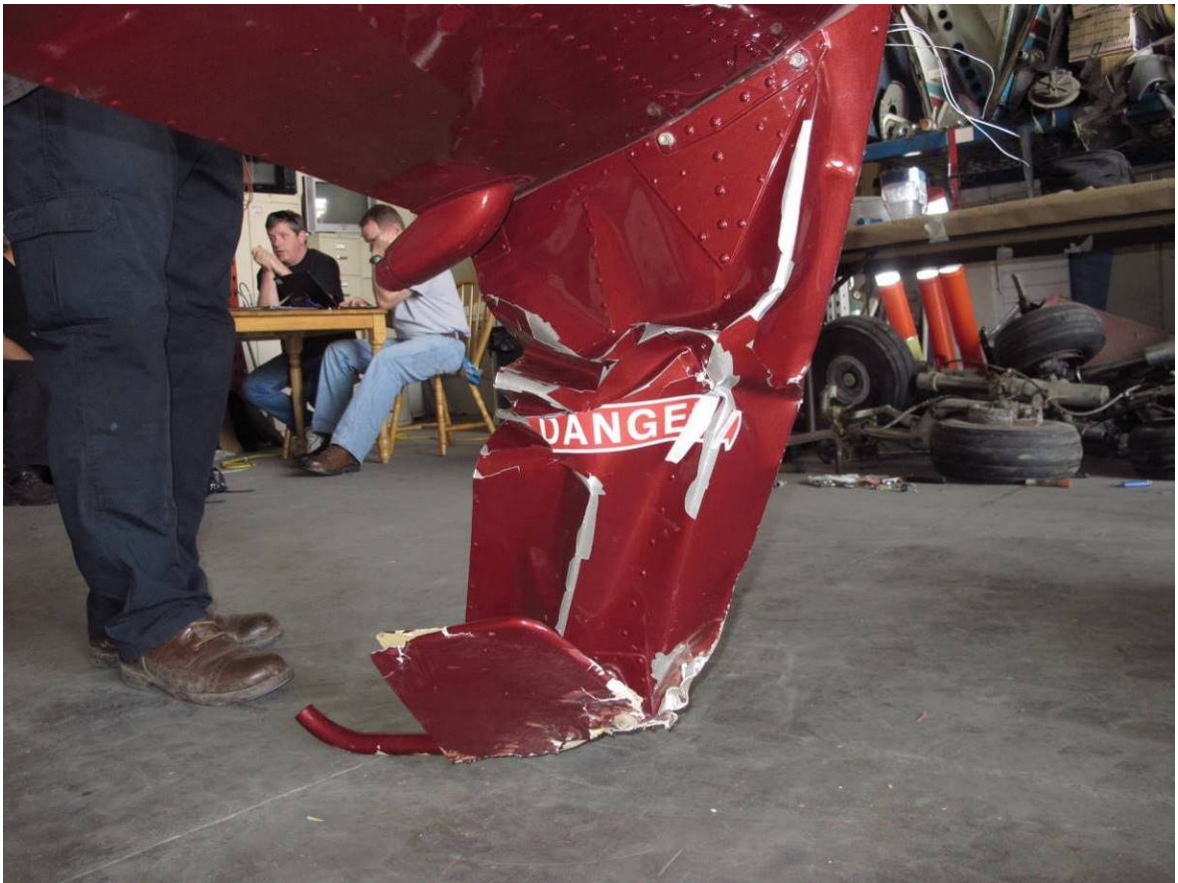
The lower vertical stabilizer, from the left side of the aircraft

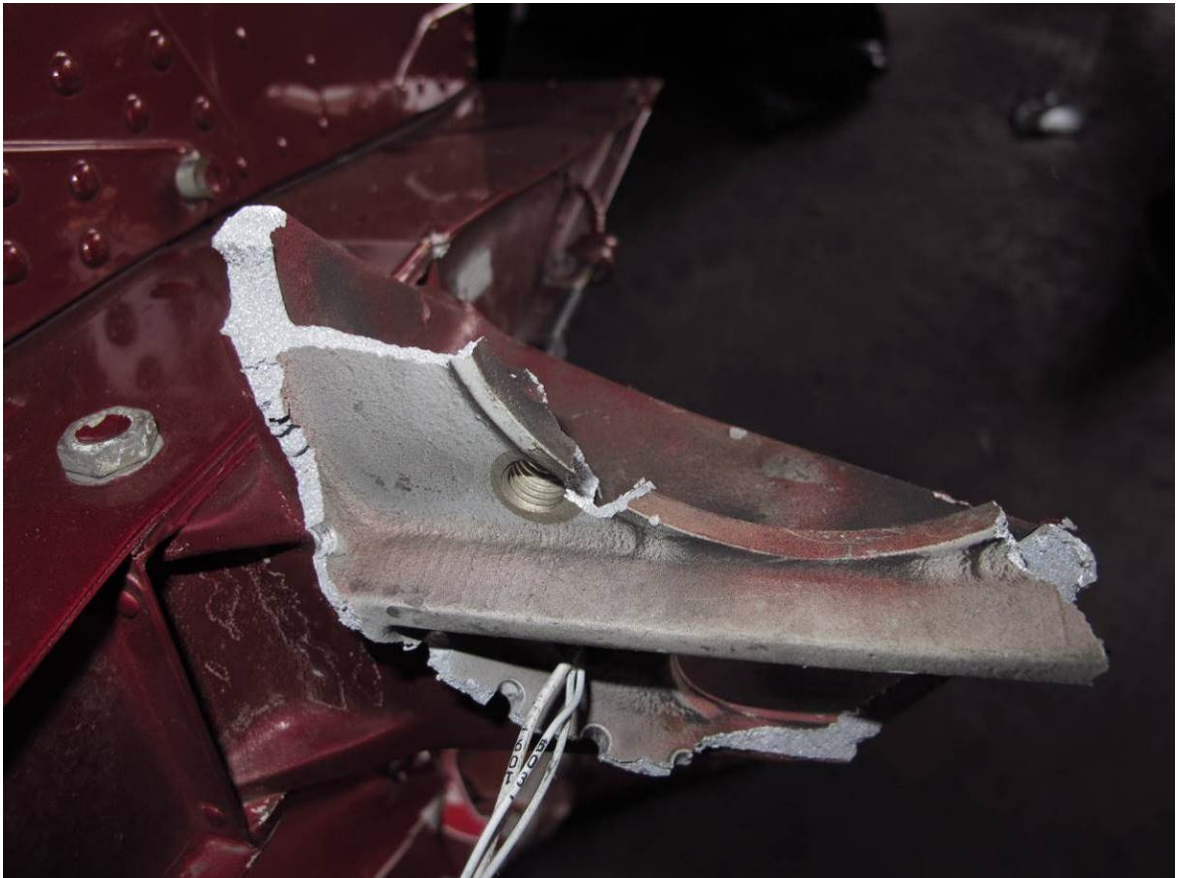
The empennage, at the casting bulkhead separation

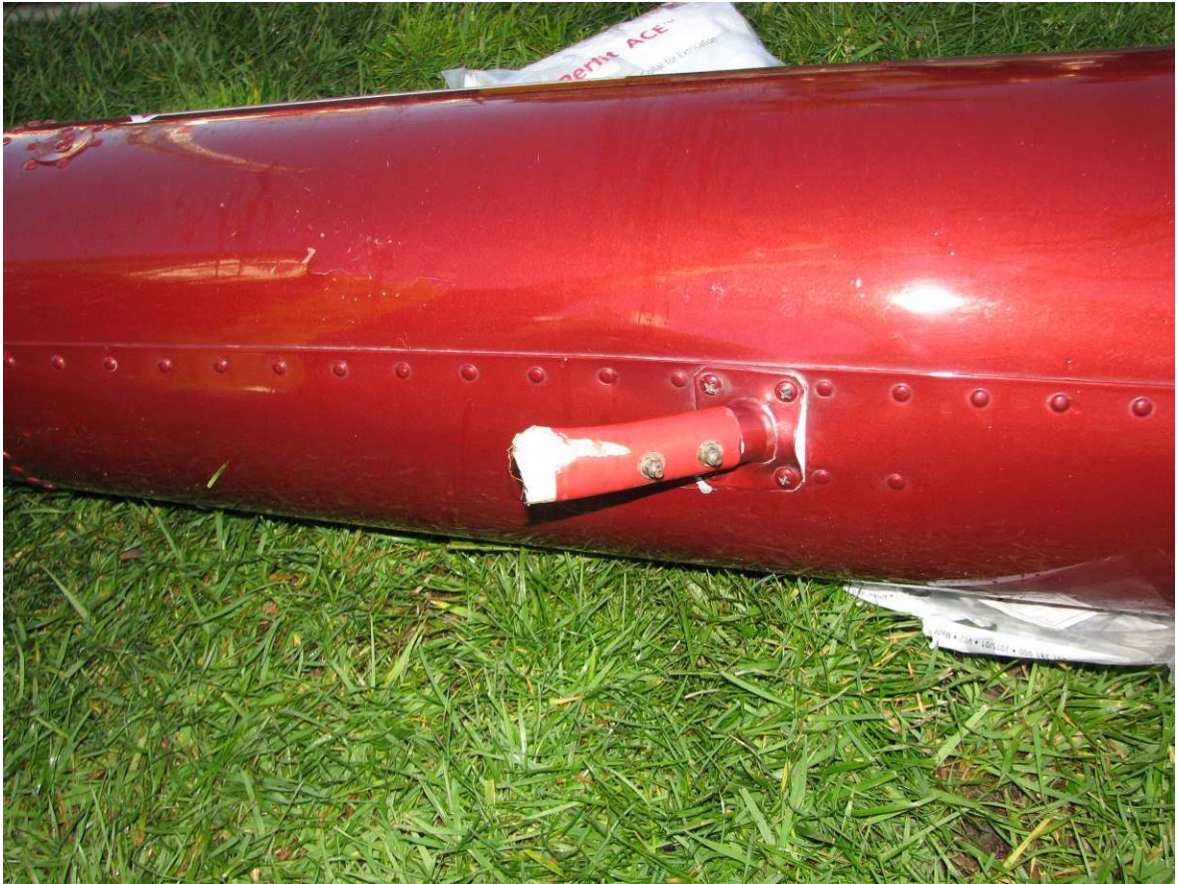
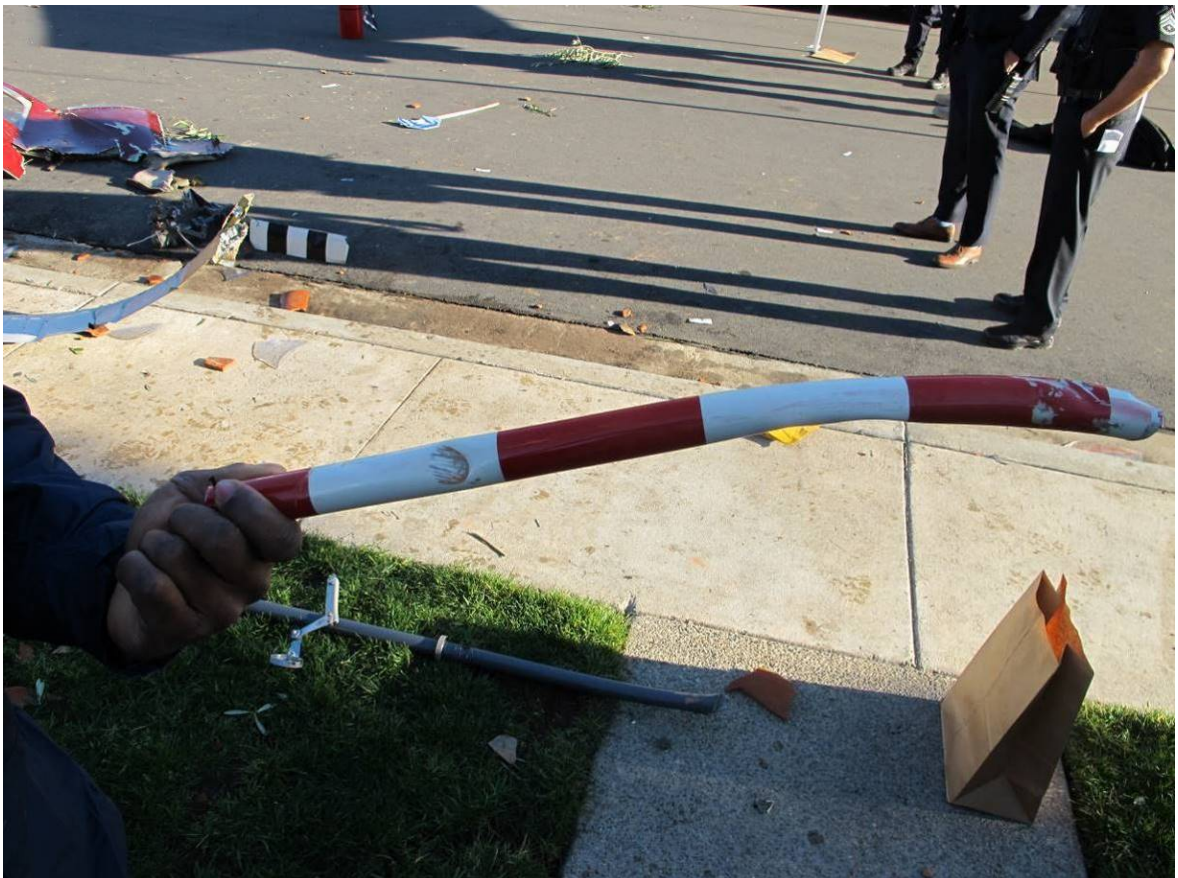
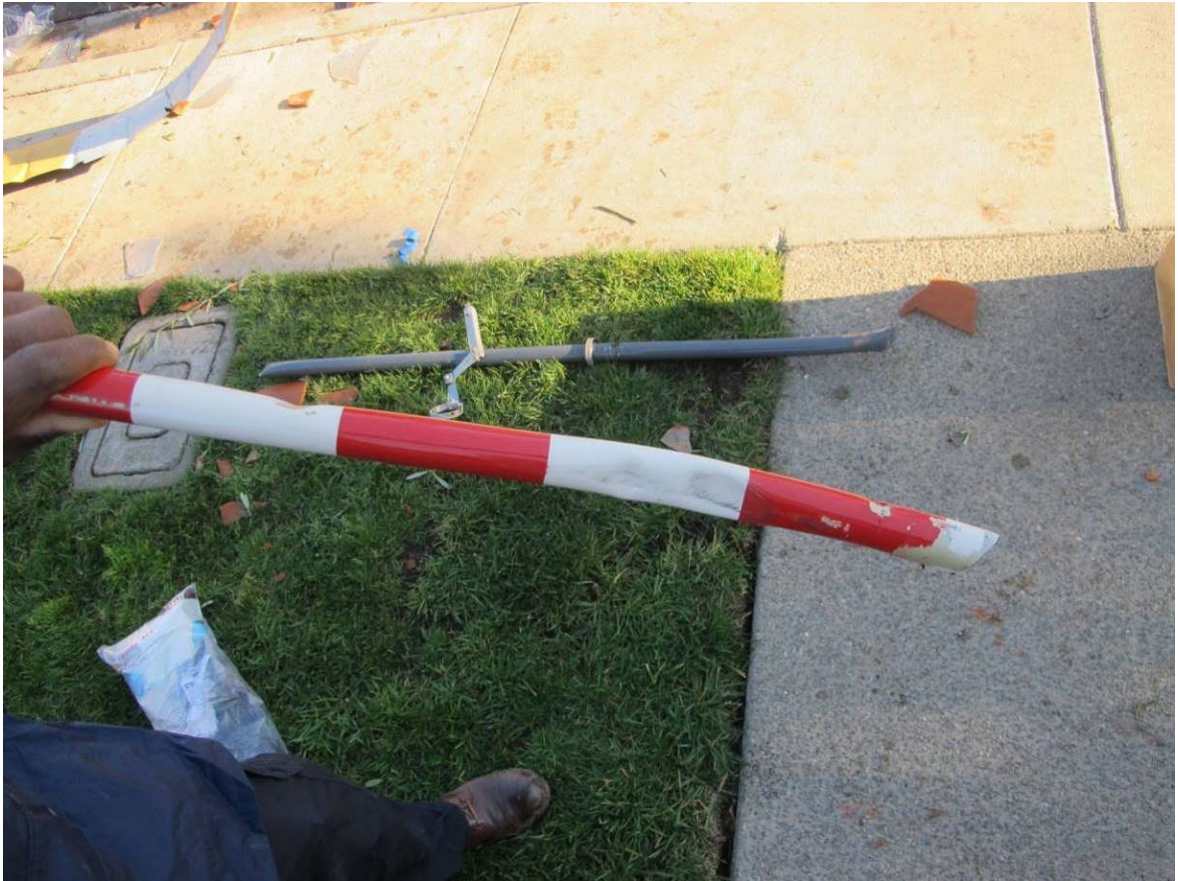
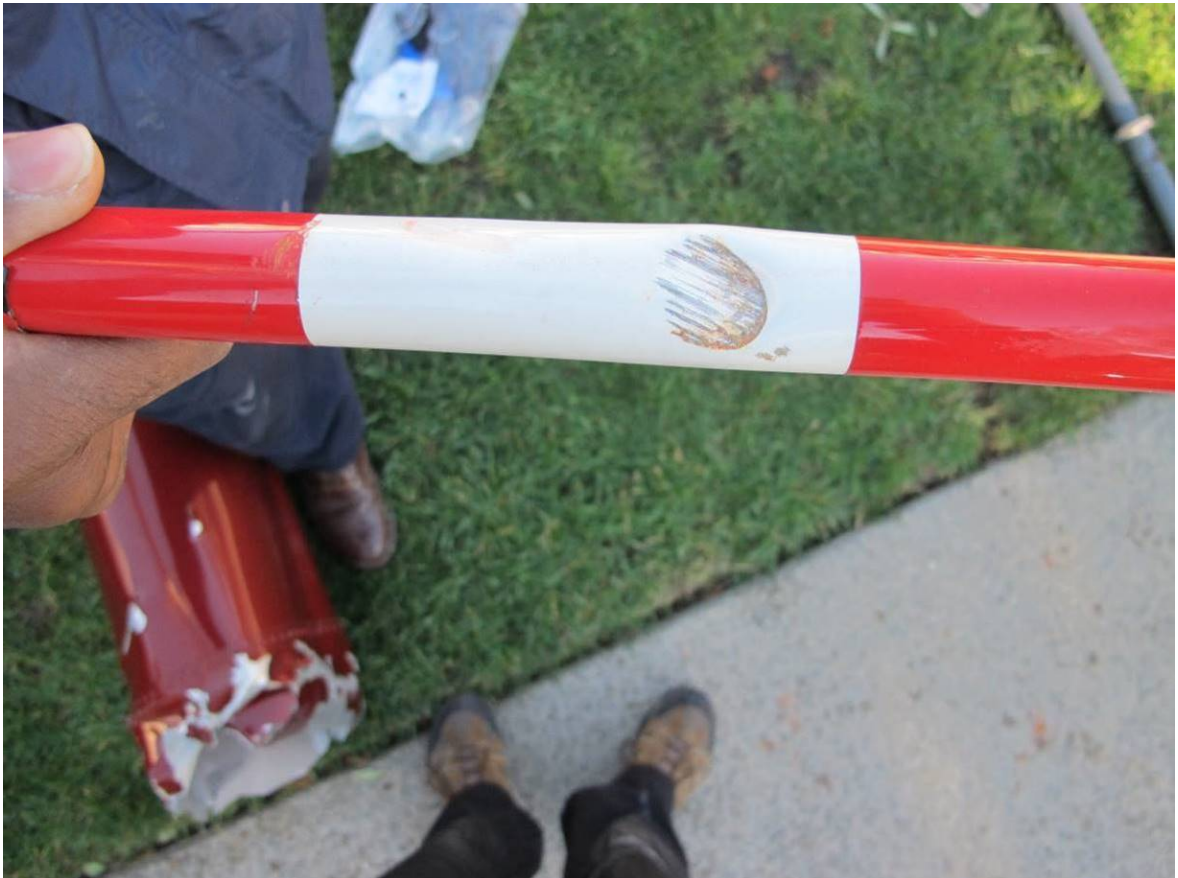
The tail rotor guard was separated in three places. The ends were flattened at each separation and the surfaces of the fractures were angular and jagged. The four sections had several contact/scuff marks with material transfer of various colors.

The forward attachment point of the tail rotor visual guard

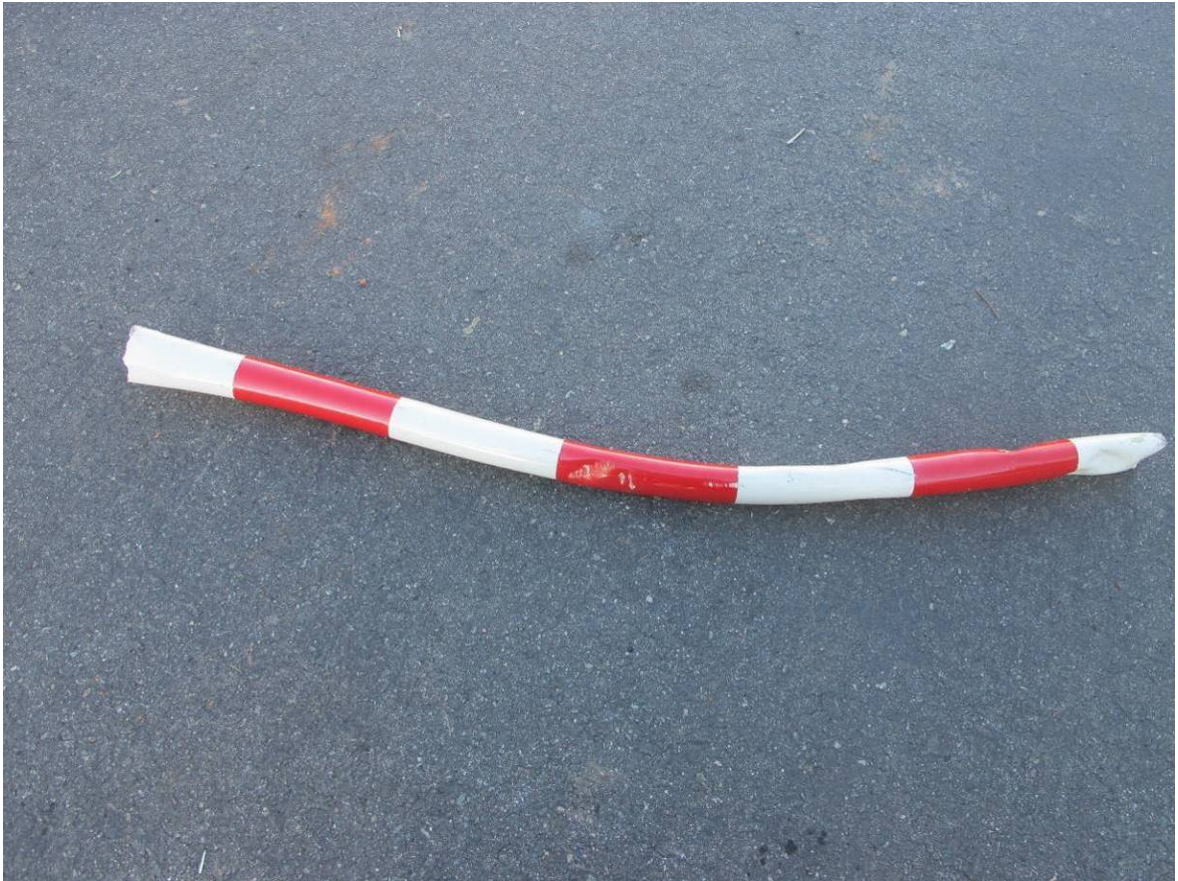
Detached portion of tail rotor visual guard number 2

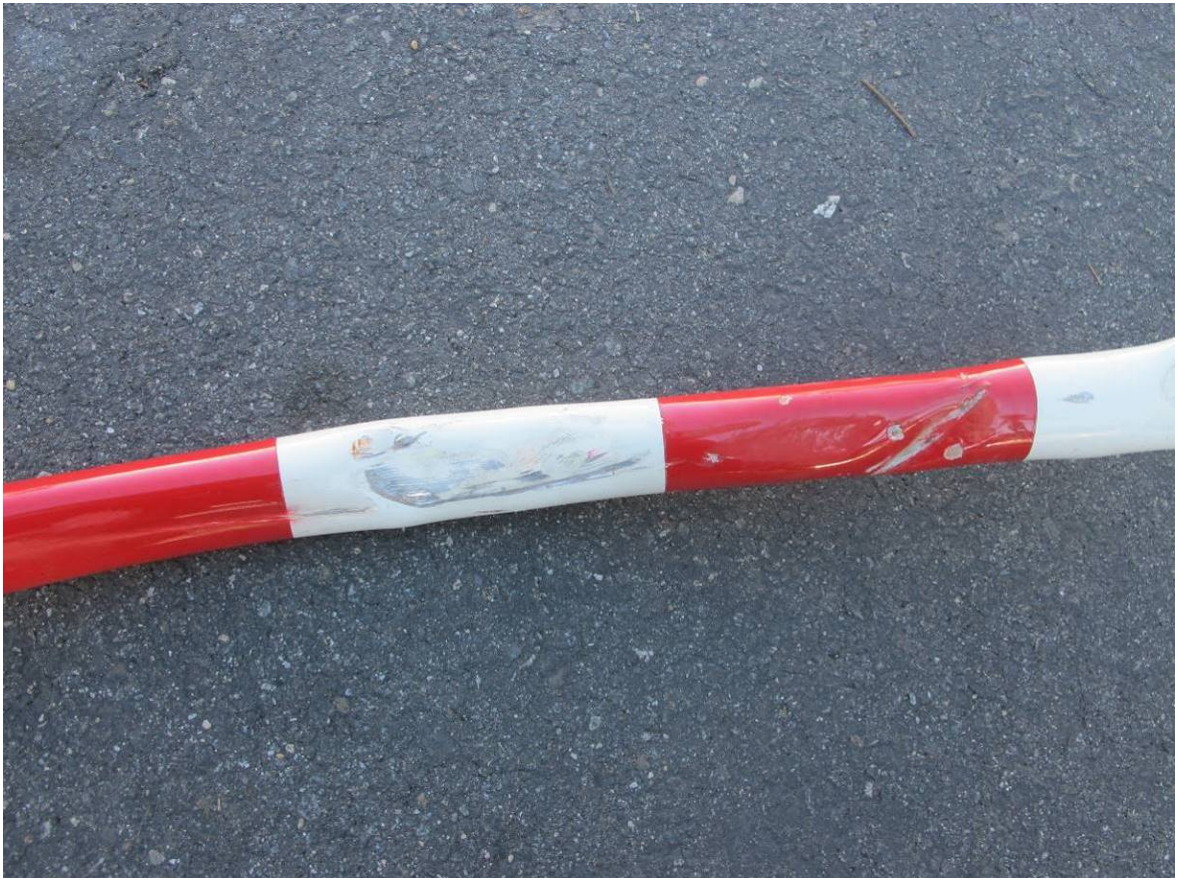
Detached portion of tail rotor visual guard number 2

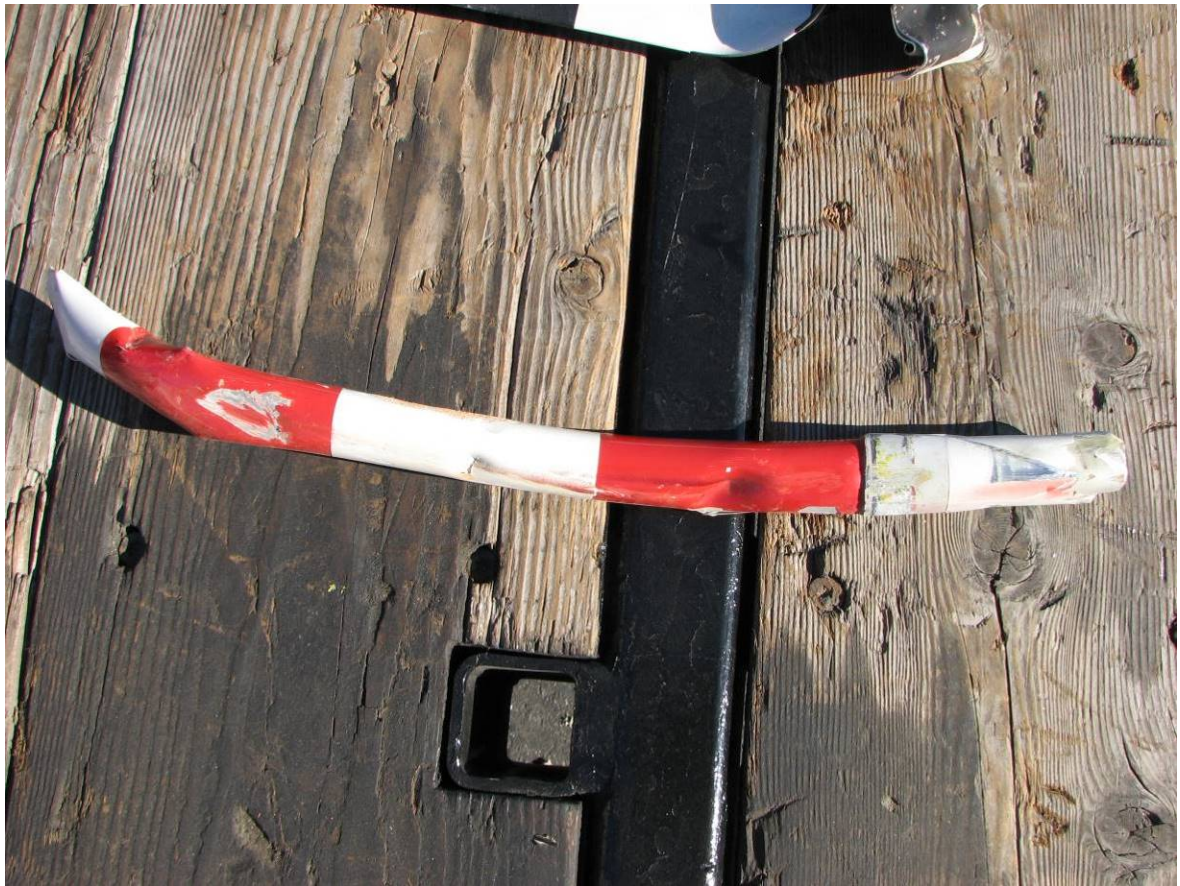
Detached portion of tail rotor visual guard number 3

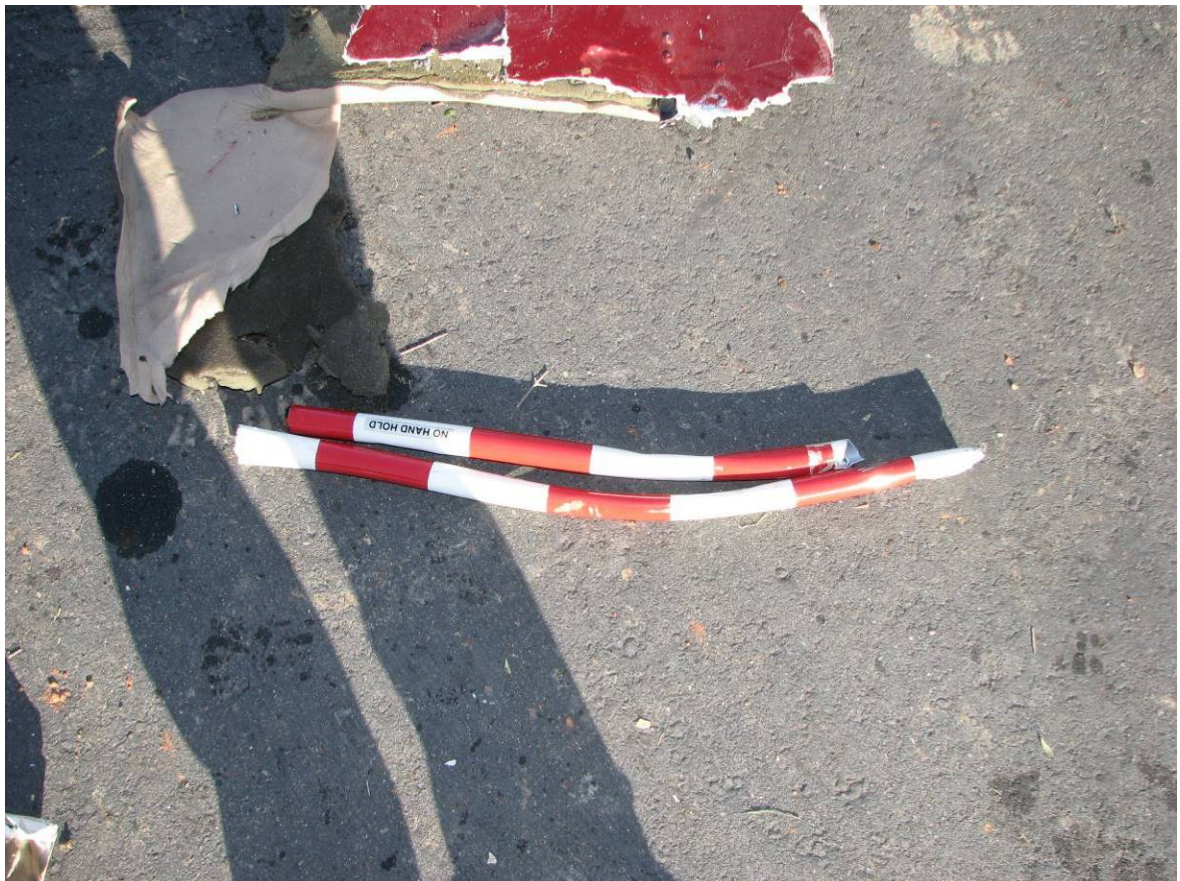
Detached portion of tail rotor visual guard number 4 (upper in photo)
